Tapered Doppler Shunt Prevents Two Cerebral Emboli

William W. Angell, M.D. FACS

Department of Surgery, Memorial Hospital of Tampa, Florida

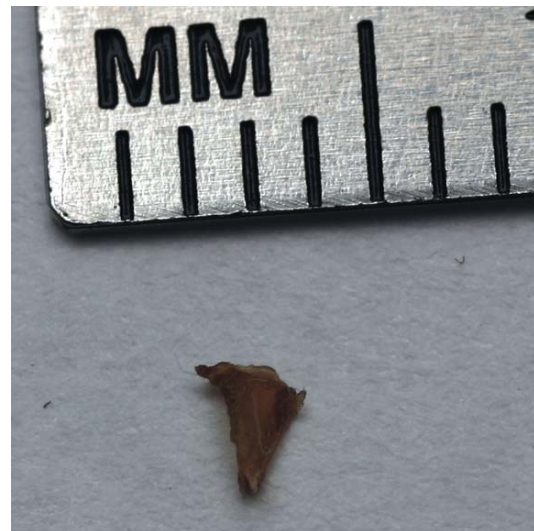
One year later, again during a routine carotid endarterectomy, the same course of events occurred. The Doppler monitor indicated a drop in volume, followed by complete cessation of the signal. Upon examination, the plaque found within the tapered shunt was

photographed. *see picture. EEG monitoring was used during both cases and no changes were recorded.

When this was reported to the company, we were informed of four reports of similar experiences by other groups, who were using the tapered shunt with Doppler. A weakening signal followed by complete cessation of sound is precisely how the system is designed to function. Fluctuations in flow related to blood pressure and heart rate have a direct relationship to the pace of the audible signal being produced by the Doppler transceiver. In our opinion this makes a strong case for the use of tapered shunts with Doppler monitoring.
